Investigation Report – PG & E Concrete Driveway and Garage – Weight Load Failure
March 11, 2016 – April 17, 2017

Lead Investigator **Matthew T. Kisak, P.E.**
Consultant **R Sinclair Group, LLC**
Date of Report **08/10/2019**
Subject **Concrete e Driveway and Garage – Weight Load Failure**

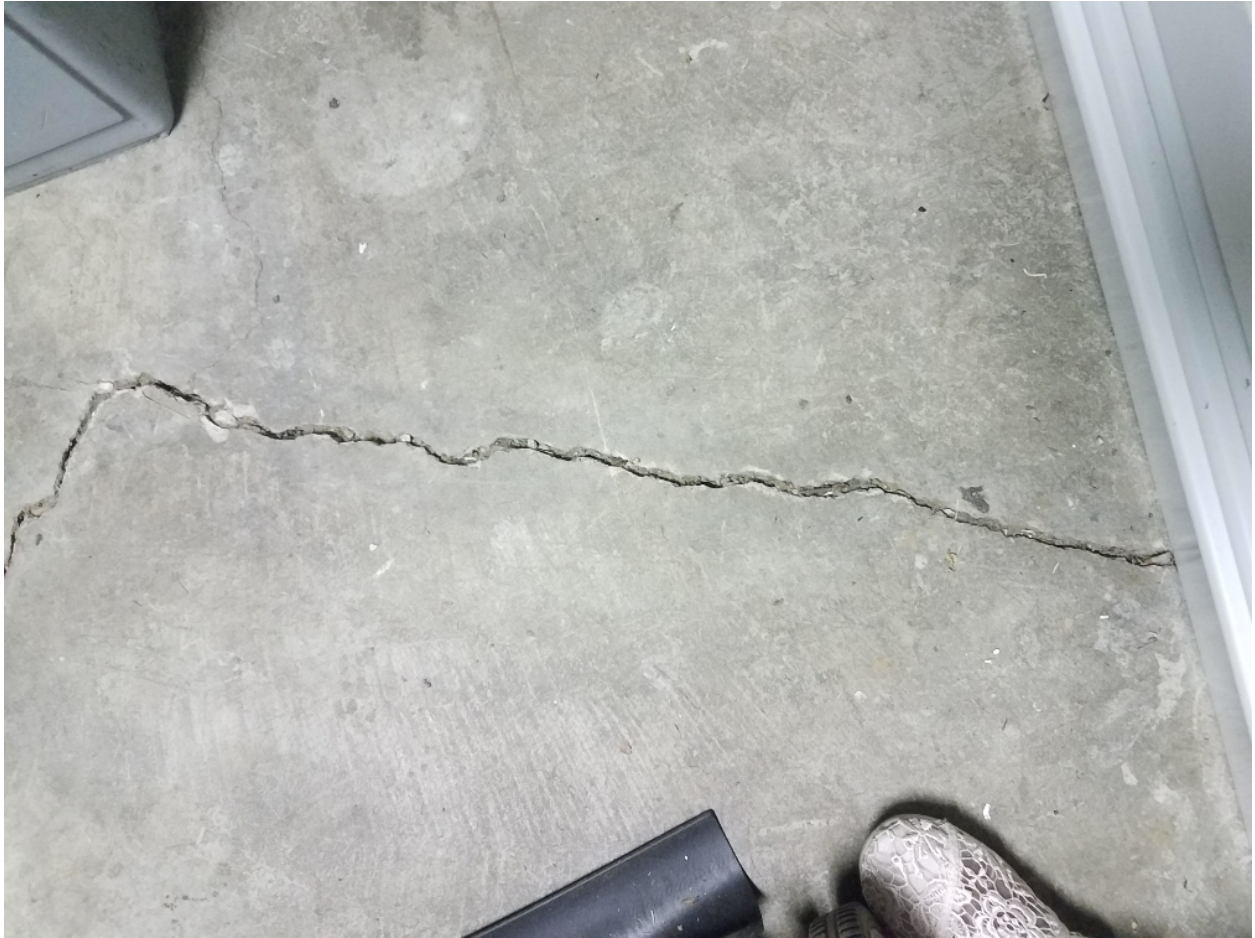
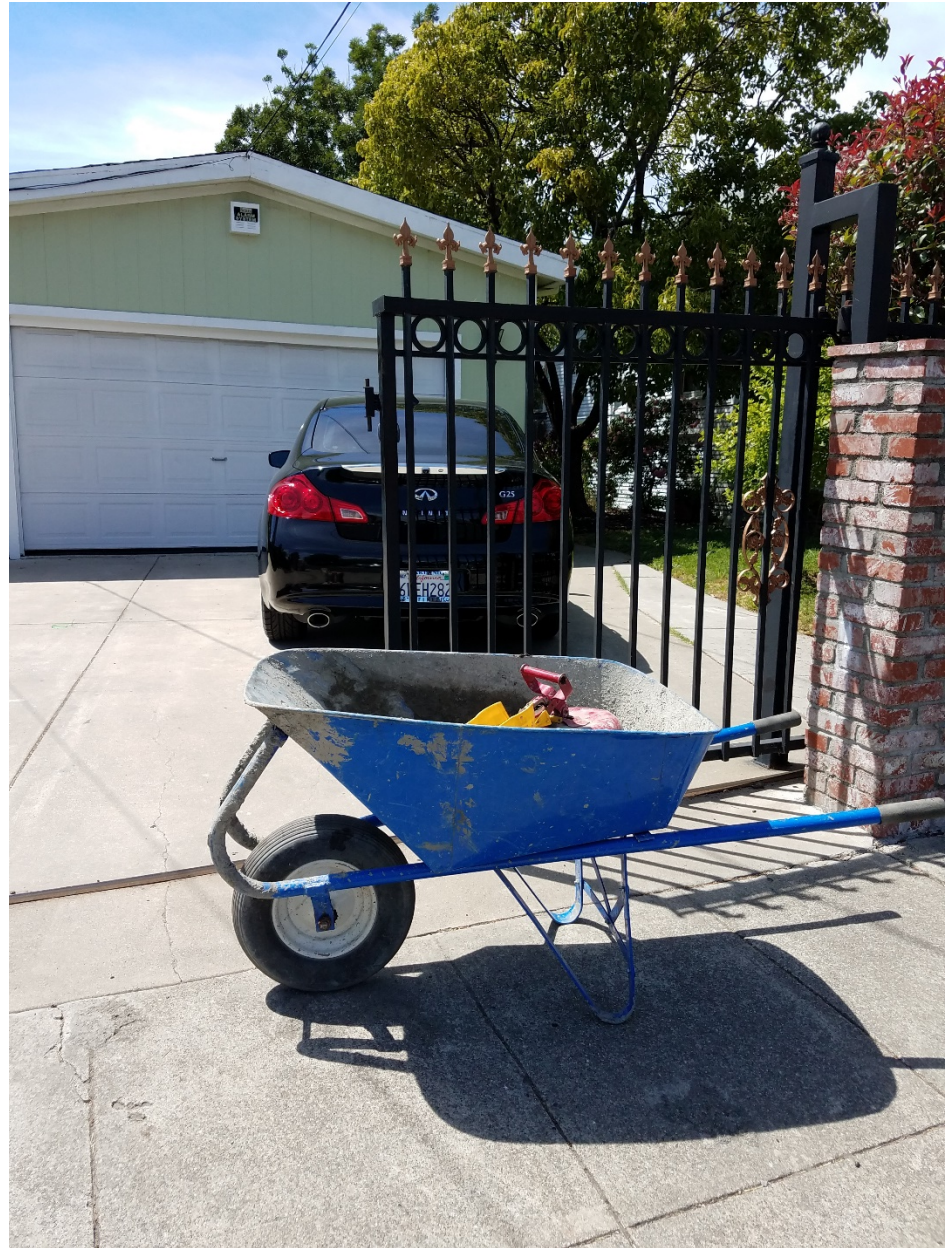
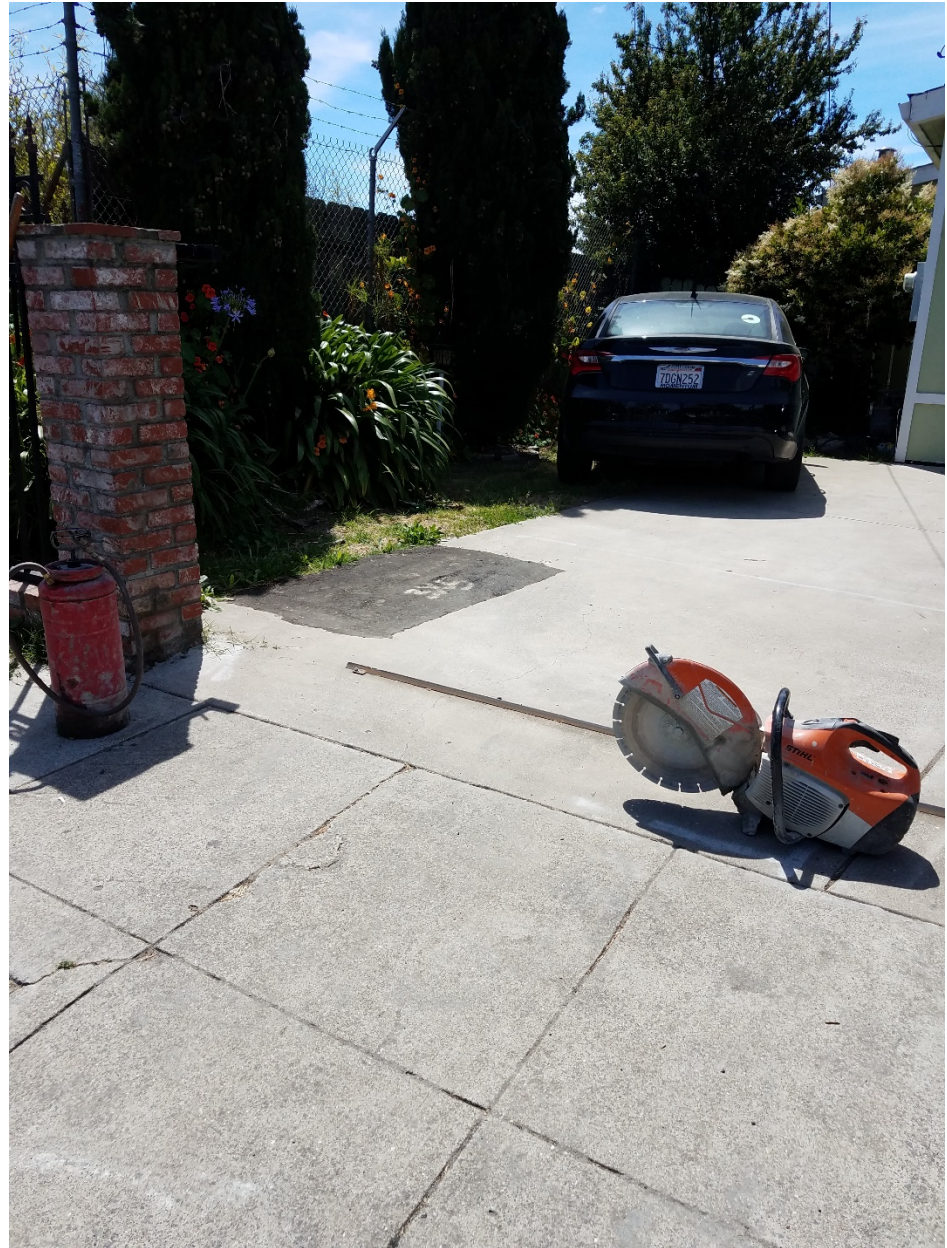
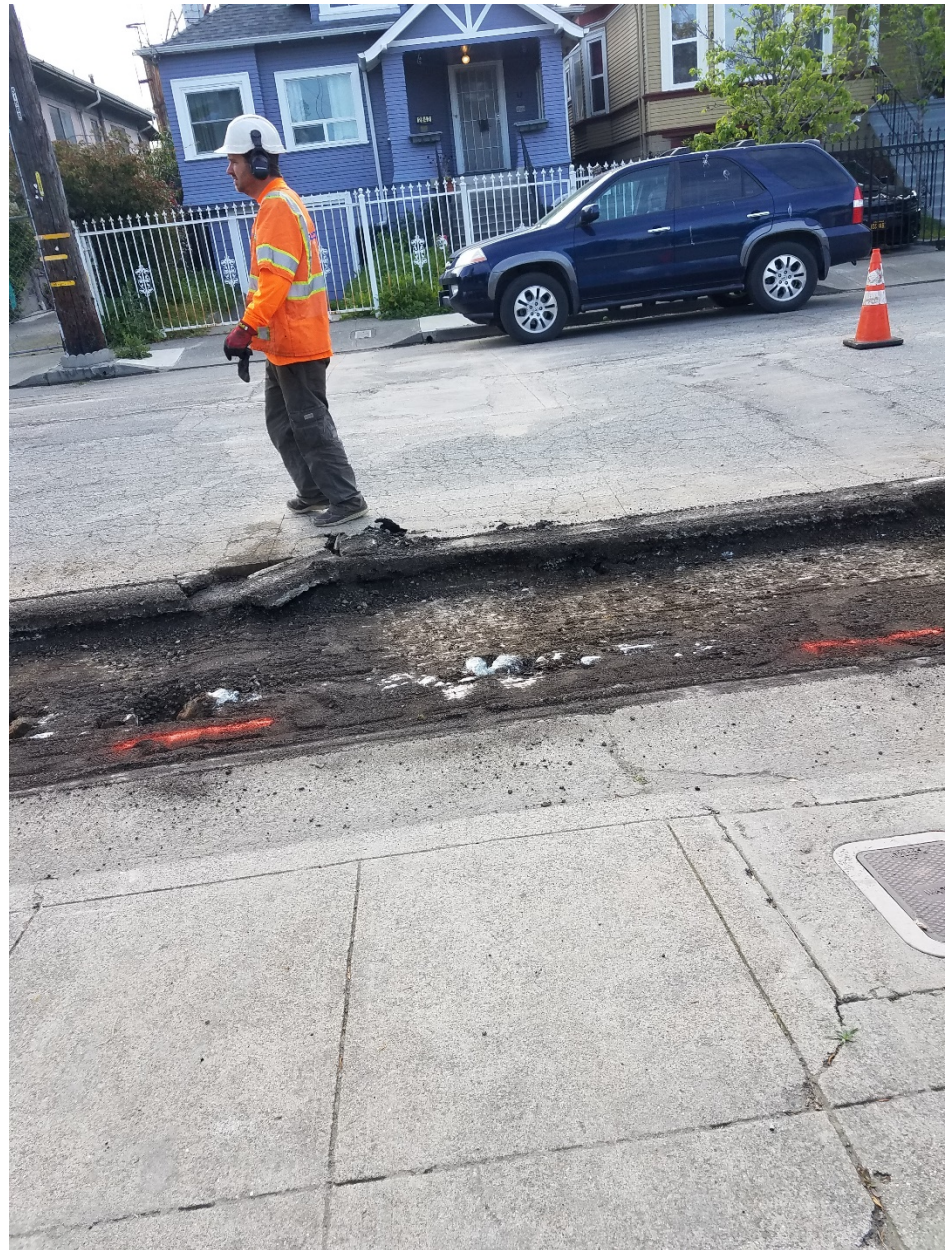
Appendix A – Photographs

1. The “7 to 4 inches” Damaged Concrete Driveway and Slab failure was due to excessive weight and vibrations.
2. These factors were caused by heavy equipment being operated on and in proximity of property.
